Manhole Inspection Summary

Manhole # S19II_034MH

Location Address: **1801 APPLETON-MONROE** Cross Street: **WESTWOOD AVE**

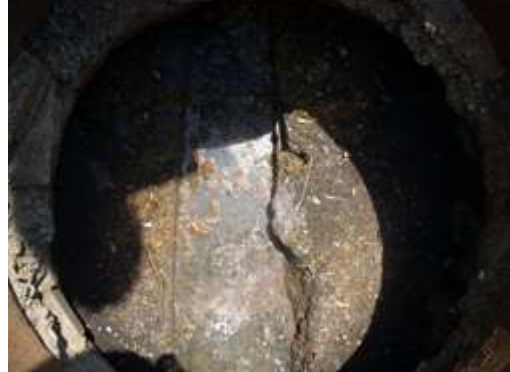
Top View

Comments **CAME TO RETAKE PHOTO - OBSERVED HEAVY GREASE IN LINE - THAT WAS THE DEBRIS IN CHANNEL. THE BENCH IS MISSING ABOUT 3 BRICKS - DETERIORATION. REWORK COMPLETE.**
